Reconstruction of Wheelwright House

Woods Hole, Massachusetts

by Dr. Charles U. Lowe

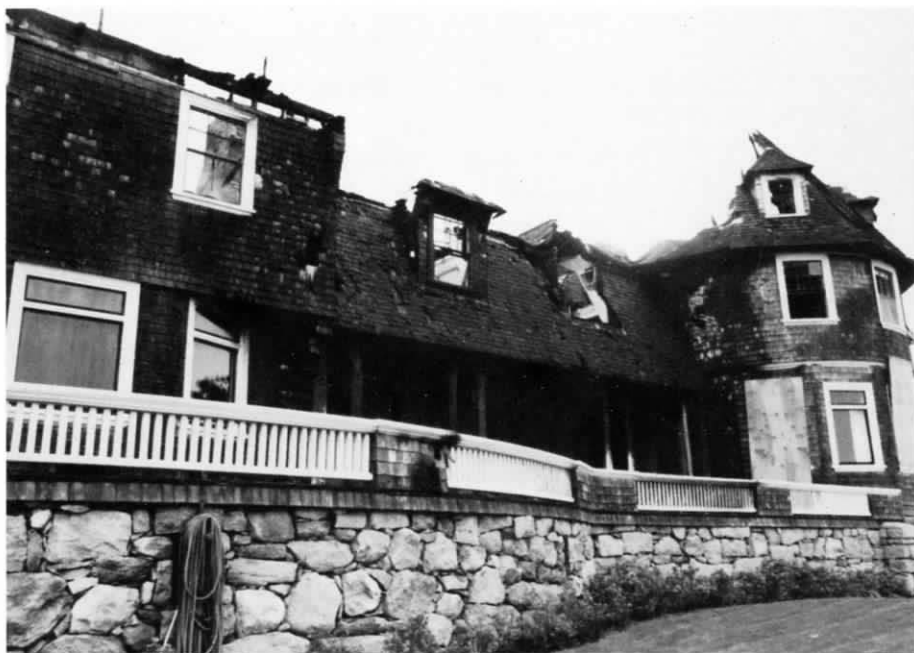
Wheelwright House after the fire.

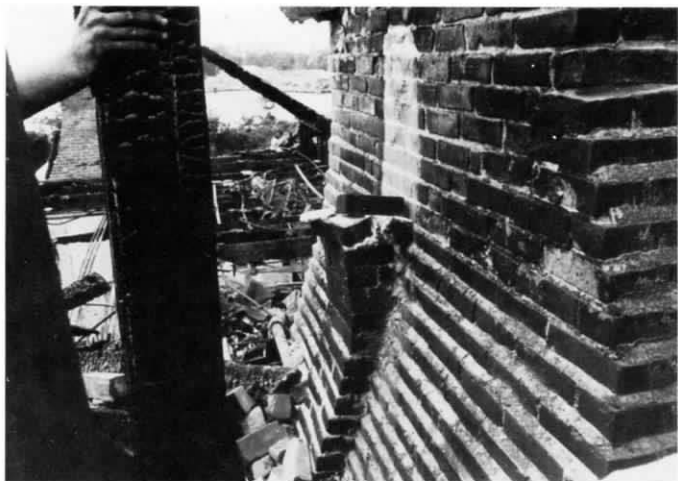
Work involved in removing chimneys before reconstruction could begin.

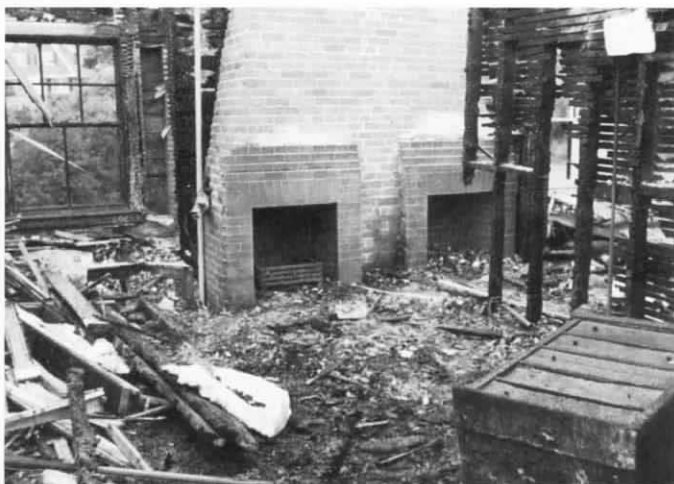
Rubble that had to be sifted by hand in search for hardware.

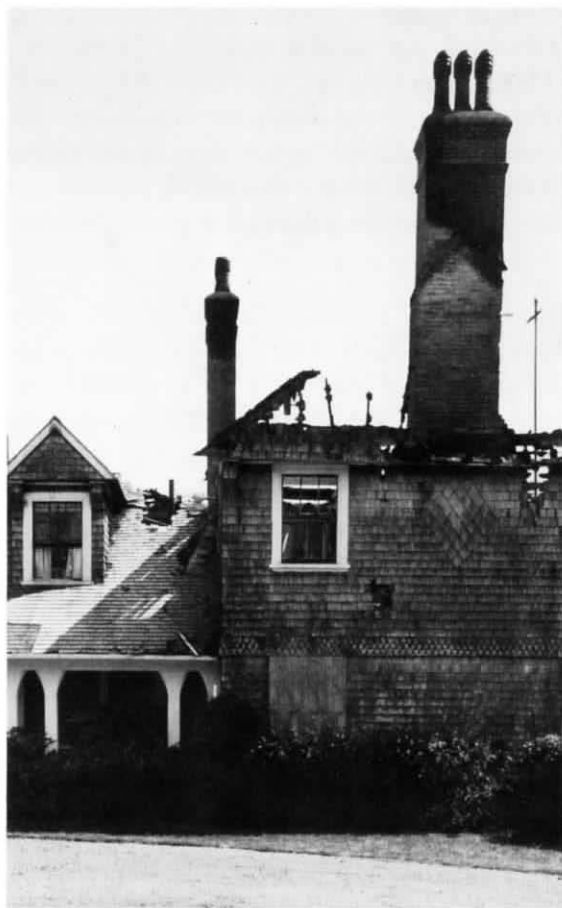
Chimneys and chimney pots after the fire.

The building inspector condemned the building until the three chimneys could be taken down. These were photographed and the courses of bricks were counted before demolition began. A crane hoisted two workmen above the chimneys in an attempt to remove intact each of the 16 chimney pots topping the flues. When they were lowered safely to the ground, it was immediately apparent that they had become so brittle as a result of the combination of the extreme heat from the fire and the abrupt cooling from the firemen's hoses as to be structurally useless. They did however become models from which to make the new pots.

Since the chimney pots were unusable, it was necessary to find a replacement source. There appeared to be only two manufacturers in the United States and neither would do custom work. We located a cooperative pottery in England but ultimately the company was unwilling to risk shipping clay pots. Eventually we found a sculptor with a kiln large enough to fire a chimney pot. These were of three sizes, the largest being 36" high and the smallest 32" high. He literally sculpted each one and then glazed them in a second firing to reproduce the color of the original pots. We eliminated one flue that ended in a laundry room in the cellar and was of no practical use. Thus, the reconstruction has 15 rather than 16 pots. It is not clear whether Wheelwright himself designed

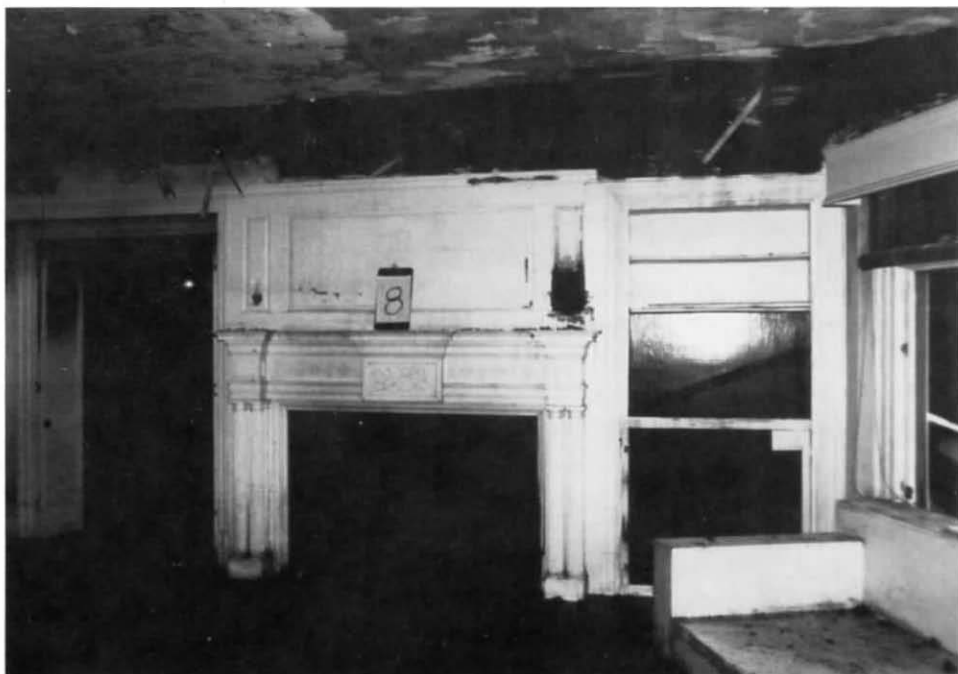
Living room showing damaged floors, walls, ceiling, fireplace detail and sconces.

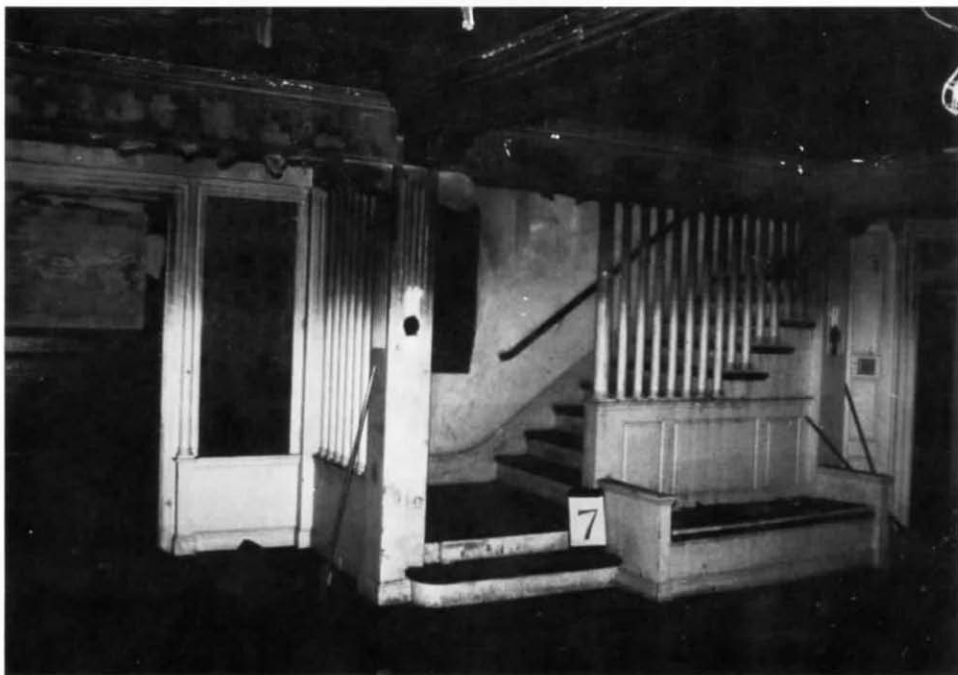
Front hall and stairs showing burned floors, walls, ceiling, decorative woodwork, sconces and leaded glass.

The large main hall contained six leaded glass inserts above the windows looking out to the sea. Five were destroyed, but one remained. An artisan was found willing to assist in recreating these lights. He removed the surviving section for study and replication. Through research he determined that the glass in the window was blown glass from Germany and he located either the original source or a source making similar glass. His recreations of the five lights are indistinguishable both in glass texture and color from the one that survived. The lead used in constructing these windows apparently was uncommon, much stronger than the lead used in modern stained glass, and he had to search the country to find similar material. It is of interest that the blown glass contains air bubbles and apparently was used by Wheelwright on the sea side of the house to capture moving sunlight reflected off the water. In other areas of the house there was leaded glass much of which was destroyed, but the fragments that remained were rolled glass and either enough structure remained to indicate the original design or photographs of the originals were available. Thus all of the leaded glass in the house was restored both with respect to the type of glass and the design.

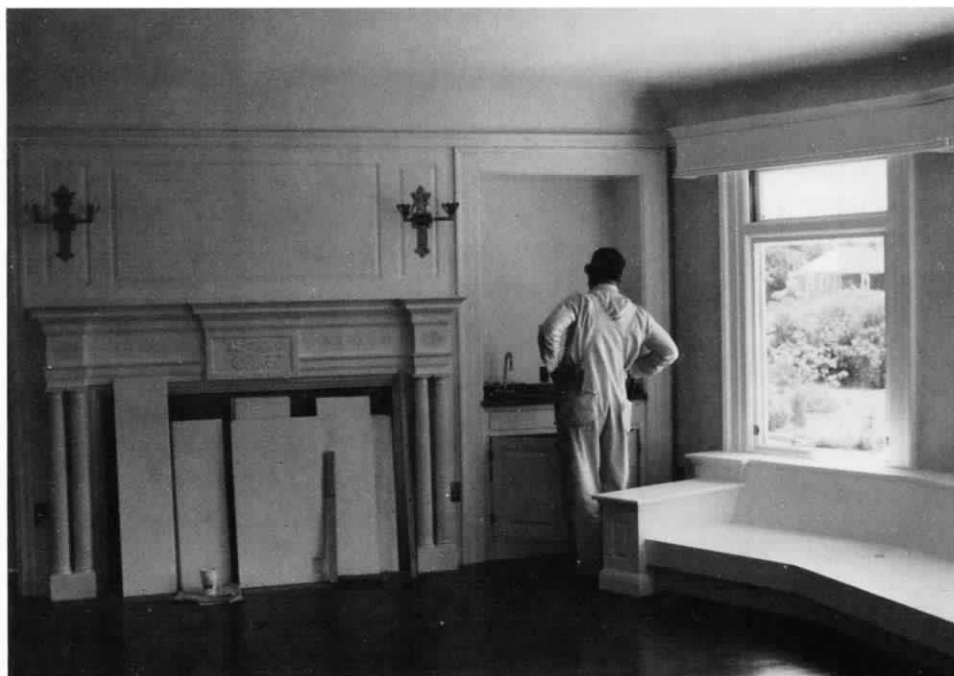
Restoration of living room nearing completion.

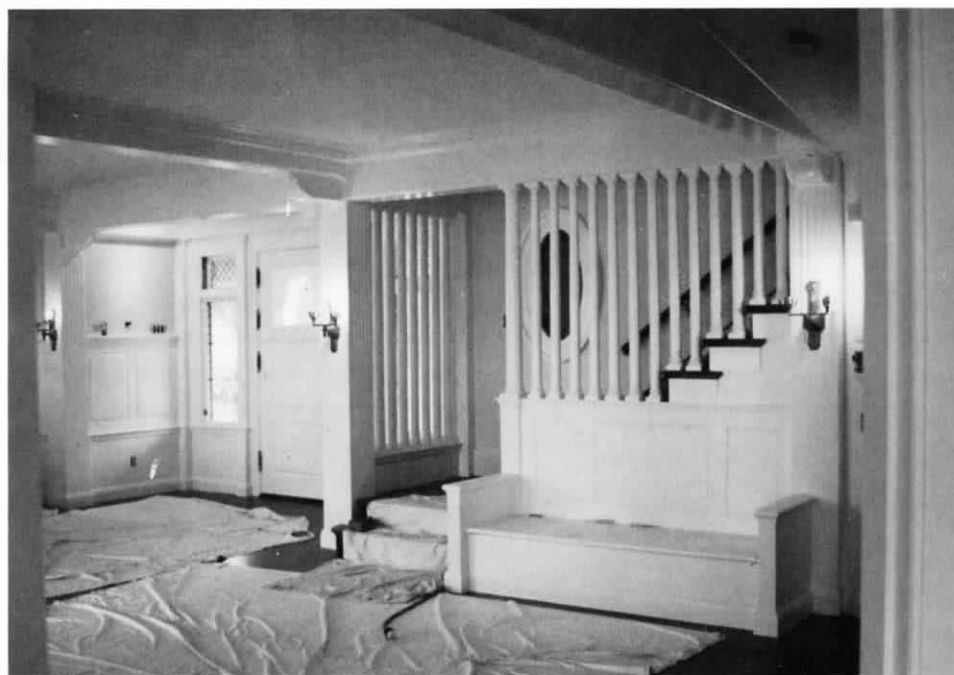
Front hall and stairs after restoration of floors, walls, ceiling, decorative woodwork, sconces, and leaded glass.

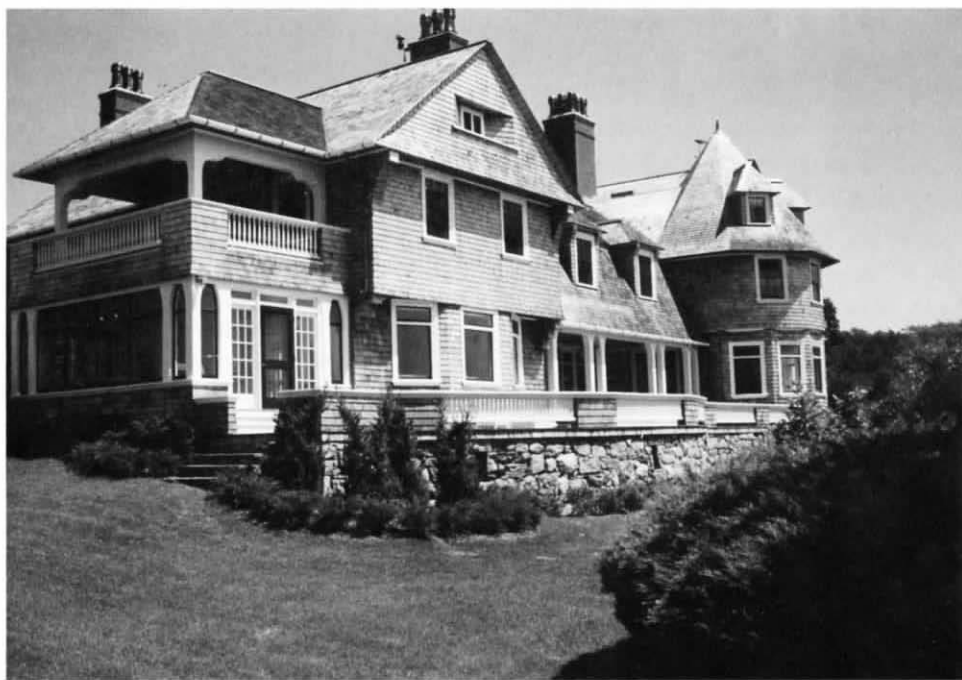
Reconstruction of Wheelwright House complete, summer 1988.
